An evaluation of steels selected for use within electric arc furnaces

L.A. CORNISH*, M. GRANT†, B. WILLIAMS†, I. WILSENACH†, and H. McALLISTER†

In October 2008, a new 3 MW platinum furnace started running at Mintek's premises in Randburg. Enviroplus designed, built and commissioned the off-gas conditioning system for the furnace. At the time it was noted that the conditioning system, consisting of a water-cooled off-gas spigot on the furnace, followed by a water-cooled combustion section, ran virtually trouble free, but after 8 months of operation the off-gas spigot had suffered considerable corrosive pitting, indicating that a change of material, from 316L to some other steel, was necessary. Test coupons of various steels were welded into the inside jacket of the spigot and allowed to function during normal furnace operation for several months. The examination of these plates is presented, together with ongoing work to find the correct steel to ensure that the spigot will not suffer a material failure between major, once-a-year, overhauls of the furnace.

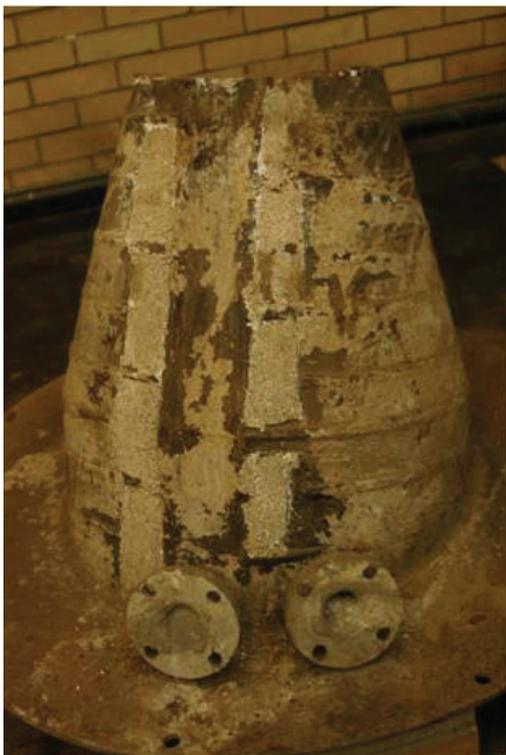
The spigot as it appeared on arrival at the University of the Witwatersrand is shown in Figure 1, and the water cooling had been disabled and plugged. Thus, the spigot would have reached much higher temperatures than had been designed for. It was also observed that the base was deformed (Figure 2), although this was later established to have been as a result of subsequent handling and not temperature.

Figure 1. Blocked water-cooling mechanism

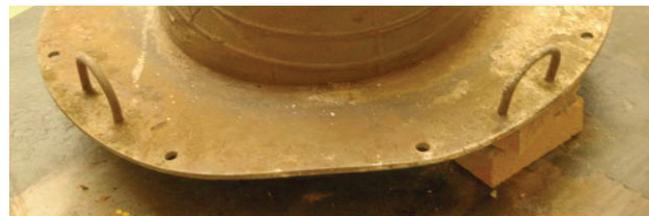
Figure 2. Deformed base of the spigot

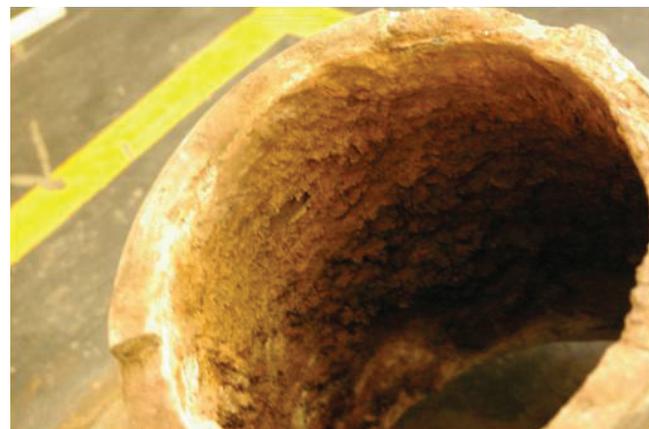
It was also seen that part of the top had been removed, as shown in Figure 3, and looking down inside the spigot, the coating inside was both thicker and coarser than had been observed in the first inspection in April 2009.

Figure 3. Top of the spigot showing the cut region and thick deposit inside the spigot

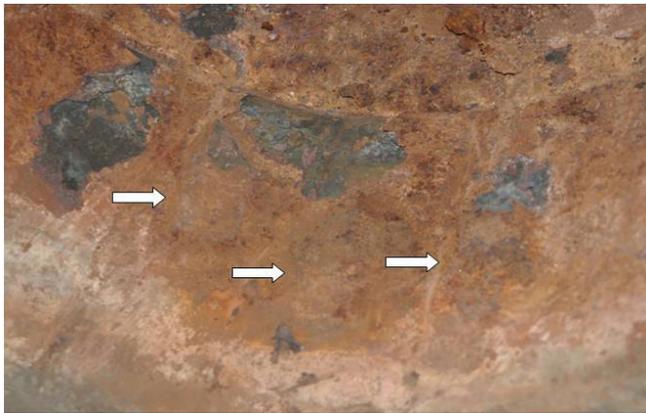
The coarse deposit was removed using a wooden dowel, and eventually, one coupon test piece was found and two stubs on the side away from the arc. This was the 2205 coupon, and is shown in Figure 4. It was also observed that the plate to which the coupons had been welded was in reasonable condition. The coupons and part of the substrate that they had been attached to was removed for metallographic examination. Higher up in the spigot was refractory casting, which had also been added at the previous failure. No evidence of the coupons was found on

Figure 4. View inside the spigot showing the only coupon that was recognizable (left hand arrow), with the stubs of two other pieces (central and right arrows), all welded on new material near the base

Regarding the coupons, on the side nearest the arc, none was found, and this meant that the conditions were too severe for these to survive, or that the welds had failed. (No information was available on the welding.) This was initially surprising because it was expected that this region would actually be more sheltered. The 2205 coupon was the only one on the opposite side to survive intact, although two stubs were also found which were too corroded to be identified by their shape, and showed that the welds had not failed. One coupon was missing totally, and could have fallen off from the left side of the 2205 coupon (Figure 4).

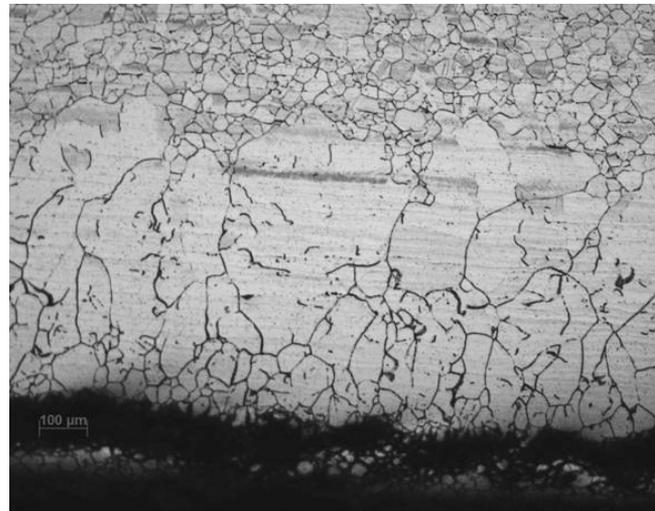
The etched sample showed that there was also spalling, with corrosion products spreading underneath the substrate. The grains near the surface appeared much larger than those further in (Figure 6). However, this was more because the uneven precipitation of the carbides on some of the grain boundaries only.

Figure 6. Optical micrograph of etched 316L sample showing carbide precipitation and apparent grain growth at the surface

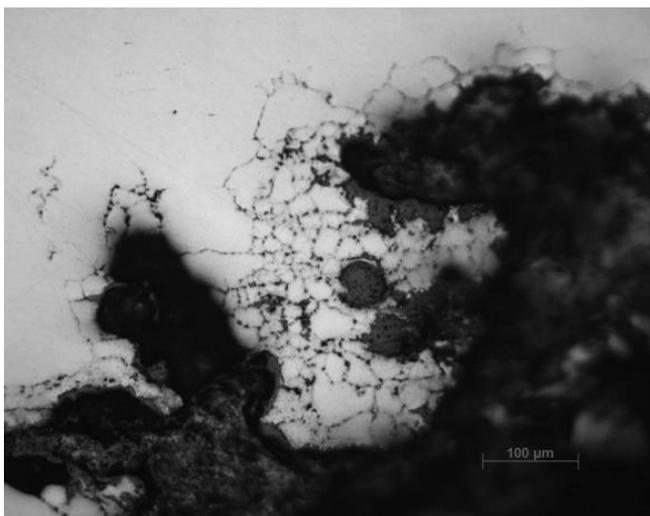
Grain boundary corrosion was clearly seen in the unetched 316L specimen, and the precipitation of carbides could be seen at the grain boundaries beneath the surface (Figure 5). This is classic intergranular corrosion, which can occur after sensitization. In the spigot, there could be residual stresses resulting from thermal cycles, but the high running temperatures would offer *in situ* annealing. Although the furnace did run smoothly, there were maintenance periods where the furnace was cleaned. There were also pits and corrosion products shown as broken layers on the outside. Also present were internal nodules of graphite, identified by their appearance in the unetched micrograph.

Figure 5. Optical micrograph of unetched 316L showing grain boundary corrosion and the precipitation of carbides at the grain boundaries

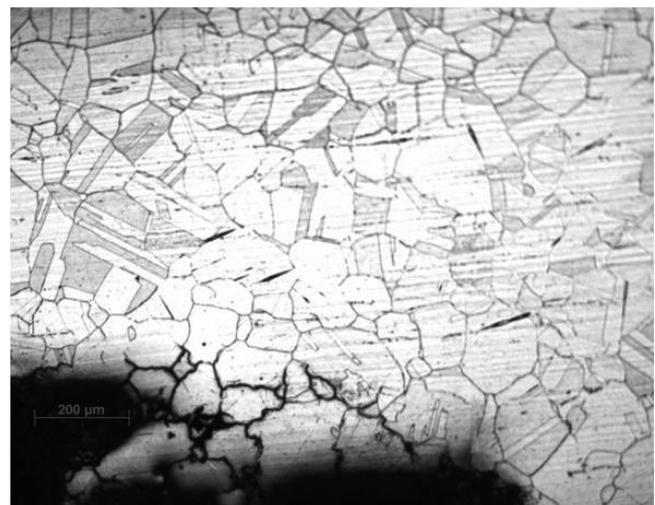
Figure 7. Optical micrograph of etched 304 sample showing grain boundary corrosion and some precipitated needles

The 304 sample also showed sensitization and grain boundary corrosion; higher sensitization than in 316L would be expected from the nominal C contents. The annealed nature could also be seen with the high number of annealing twins, which is unsurprising considering the high temperatures to which the spigot was exposed. There were also some dark needle precipitates (Figure 7).

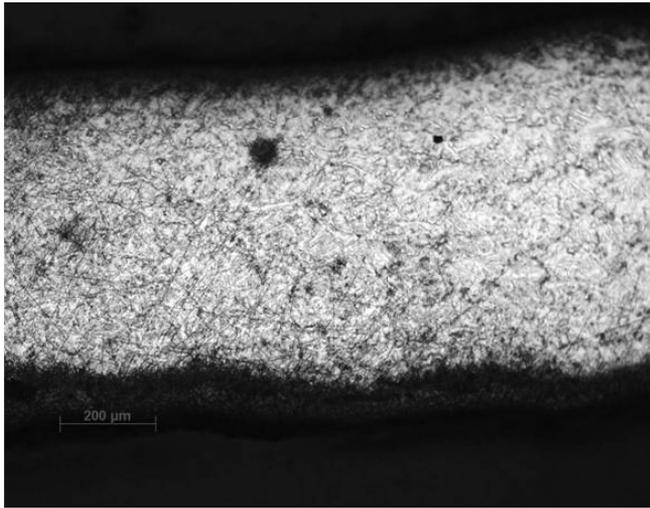
Figure 8. Optical micrograph of 3CR12 showing the dual phase nature (comprising ferrite and martensite) and layered surface (at the bottom)

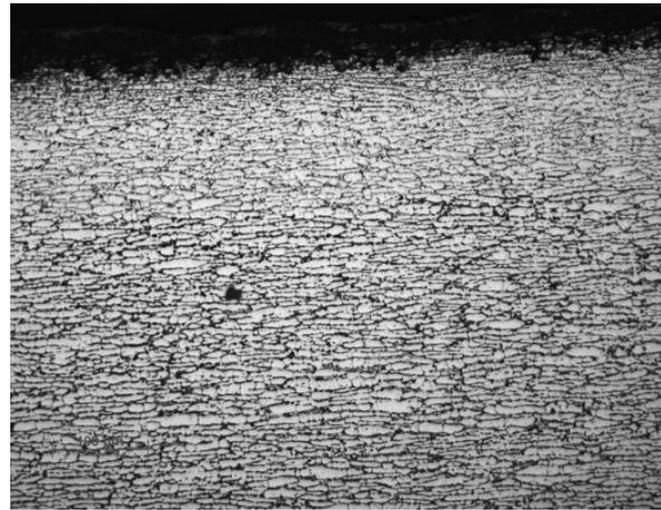
Figure 9. Optical micrograph of 2205 sample, showing fine grain size, with carbide precipitation (dark) and a scale and grain boundary corrosion at the top

Of the experimental coupons, 2205 showed the best results. It was the only one that could be identified from its original shape, and it was also the thickest coupon. The surface also looked intact, although with a dark scale. The microstructure shows that there was a scale and the surface had deteriorated. The fine grain size, still in the original as-rolled, elongated morphology, as well as carbide precipitation away from the surface could be seen (Figure 9). There was also a stained region that was a shallow pit. There was some intergranular corrosion, but the depth was less than the other steels.
