# Flexural slip thrust faulting on Booyesendal Platinum Mine and the implications for rock engineering

P.M. COUTO and W. THERON  
*Northam Booyesendal Platinum*

This paper evaluates the extent of flexural slip thrust faulting within the Bushveld Complex. Information from the literature is compared with the geological conditions observed on Northam Platinum's Booyesendal Platinum Mine during the shaft sinking process as well as stoping. Observations were taken from multiple working ends underground during the decline development stages and continuing into the early stoping stages over the past 2 years. Flexural slip thrust faulting was found to occur throughout the mining area at Booyesendal, with different intensities and under different conditions.

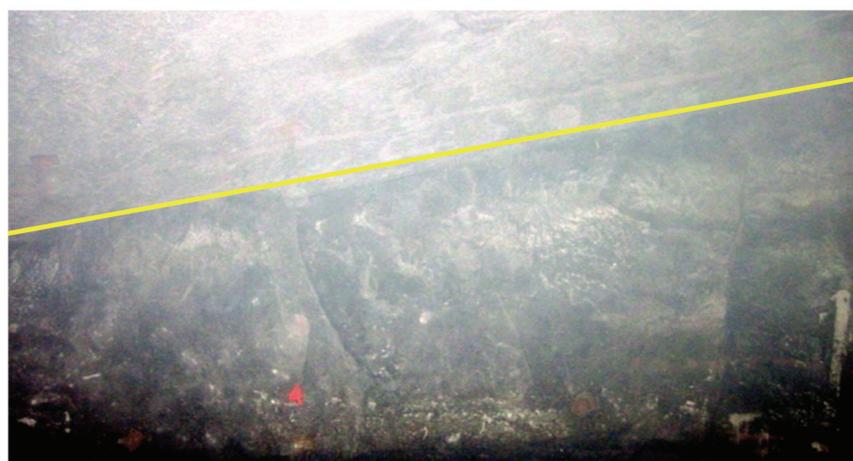
FSTF present on sidewall

FSTF is a common feature in both the BC and the platinum-rich Great Dyke in neighbouring Zimbabwe (Roberts and Clark-Mostert, 2010). Various technical publications have highlighted the risk that FSTF poses to the stability of mine excavations from a rock engineering perspective. However, there is no information in the literature as to how these faults are formed, nor regarding the identification of areas that could be susceptible to FSTF, so that mining personnel could be warned before they begin mining these areas. Figure 3 shows the dip of a flexural slip thrust fault in a stopping section on BPM.

Figure 3. Flexural slip thrust fault on the sidewall of an excavation on BPM

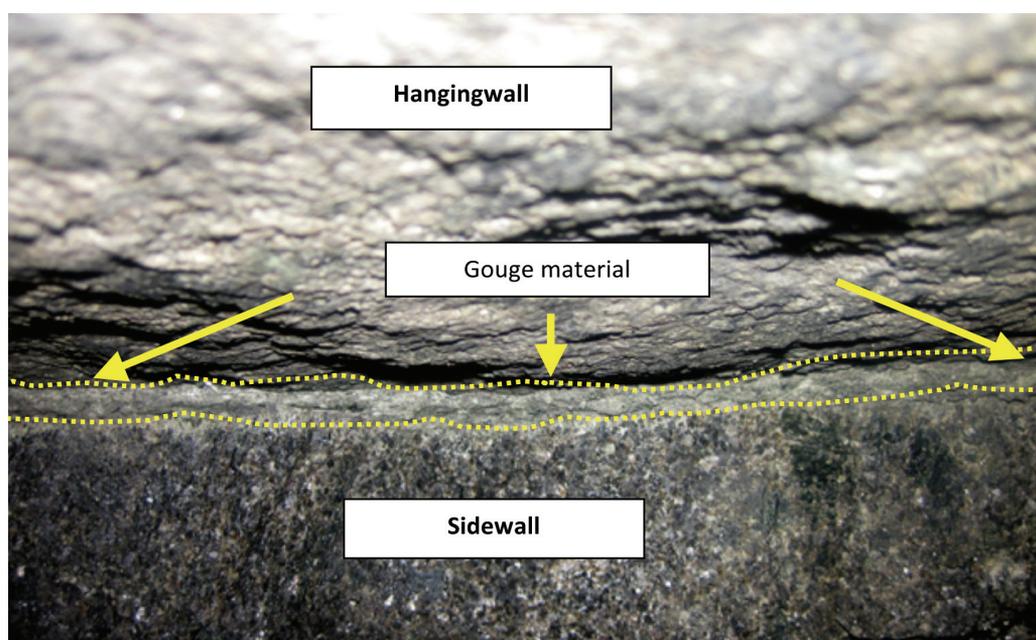
Flexural slip thrust faults have an infilling of gouge material ranging in thickness from 1–10 mm depending on the exposure of the contact to flexural stresses. Striations along the planes can clearly be seen, indicating movement.

Figure 4. Gouge material in a flexural slip thrust fault on BPM

This has been ascertained by means of borehole camera observations in the hangingwall as well as daily inspections in these areas. The thrust faulting can be seen on the sidewall as all three rock types within the mining cut are affected. Figure 4 illustrates the gouge material formed by movement between the two planes.

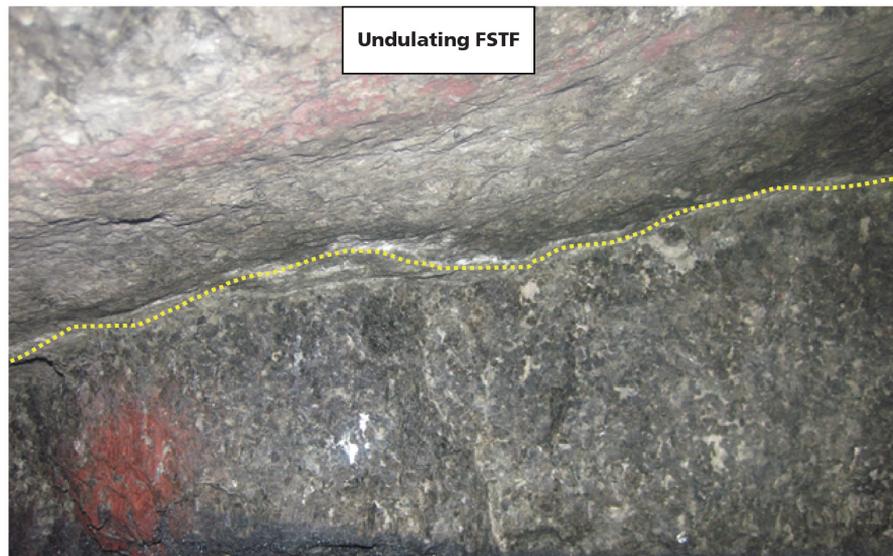
Flexural slip thrust faults can have undulating planes. This is an indication that these features formed during flexural stages early in the formation of the BC.

Figure 5. Undulating flexural slip thrust fault on BPM

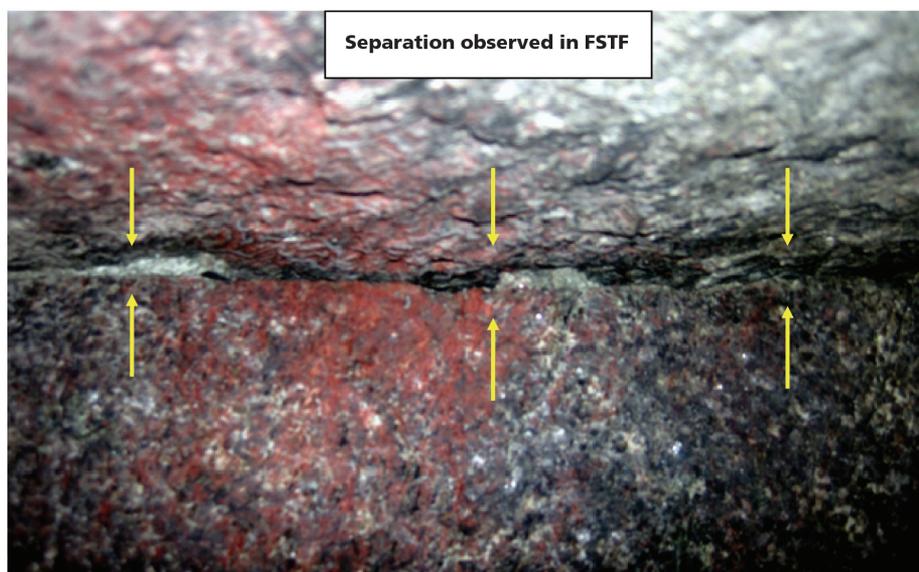
Figure 6 illustrates the possibility of separation between the planes forming a wedge structure in the hangingwall, while Figure 7 shows striations on the hangingwall plane that indicate the direction of slip.

Figure 6. Separation on a flexural slip thrust fault at BPM

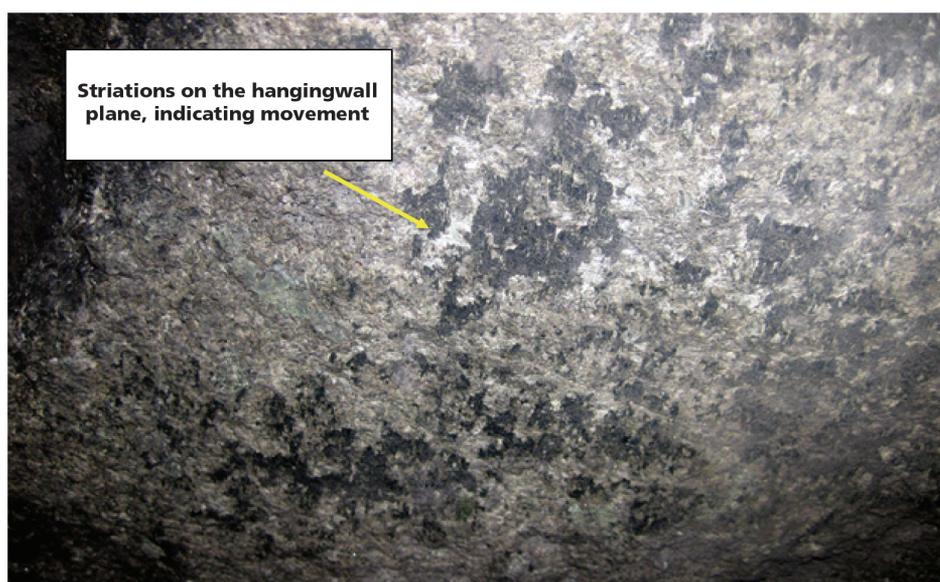
Figure 7. Striations on fault plane indicating movement

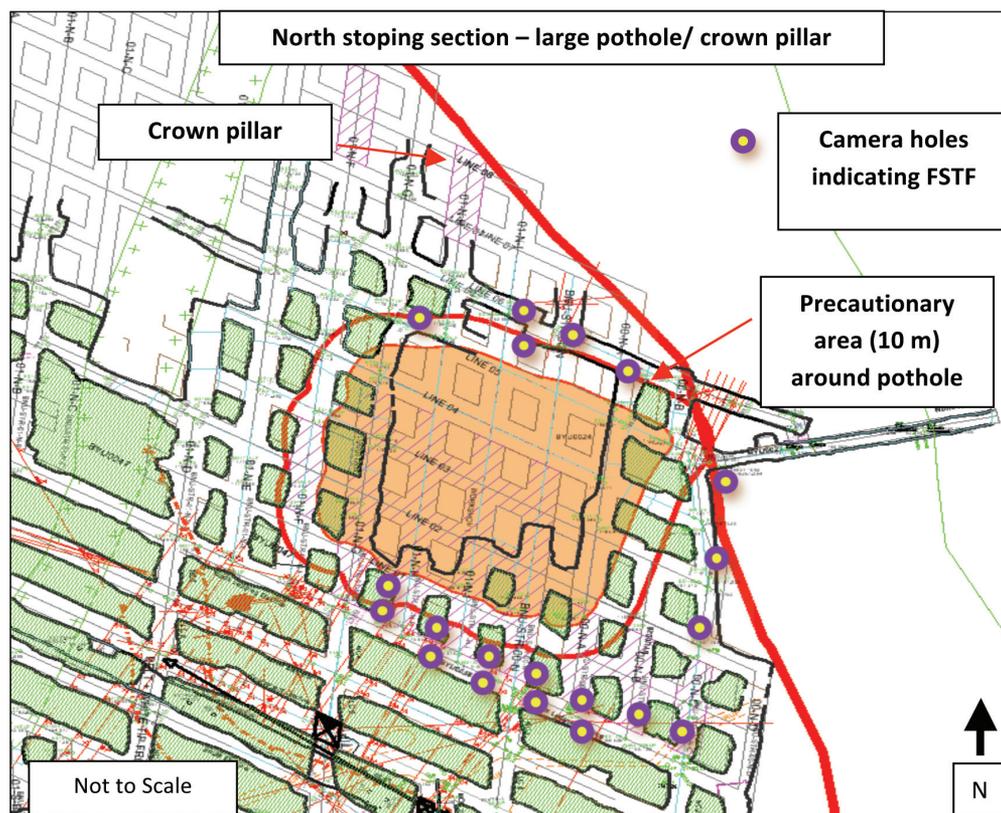
Figure 8. Plan view of pothole and crown pillar on North stoping section

geological features ahead of the excavation that will require appropriate support. Figure 8 shows an example of the borehole camera data that has indicated the presence of FSTF, together with the areas that have been identified as requiring special precautions.

Observations indicate that FSTF is found predominately within 10 m of the edges of potholes. Thrust faults can also be found around large slumps, but are not as common as thrust faults around potholes.

Borehole camera monitoring and mapping of geological features enable precautionary areas to be demarcated on the mining plan in order to warn mining personnel of potentially instable hangingwall conditions ahead of mining. Changes to the support layout can be put in place before the excavation enters the precautionary area.
