# Design constraints on trackless mining equipment in low and extra low stope hard rock mining

J.R. MENASCE\* and S.C. THORLEY†

\*TWP Consulting (Pty) Ltd

†Sandvik Mining and Construction RSA (Pty) Ltd

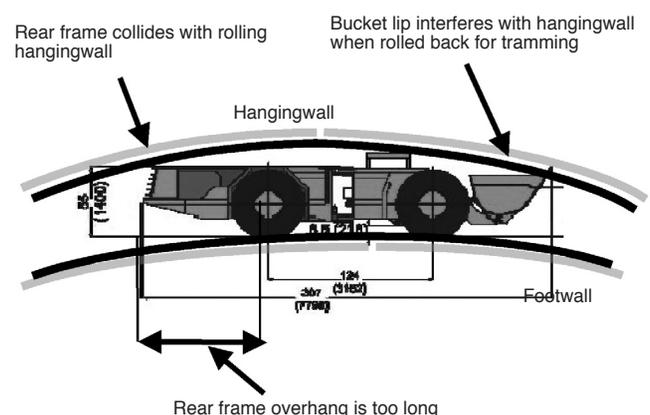
Figure 1. Initial loader profile. Dimensions assume non-undulating floor and no roof contact with frame (EJC 115LP)

Initial low profile machine design only considered the height of the machine in relation to the stope width as well as the arrival and departure angles under the ends of the

frame to accommodate floor surface variations. No consideration was given to the top of the frame, which was largely flat, with no approach or departure angles on top of the frame (Figure 1).

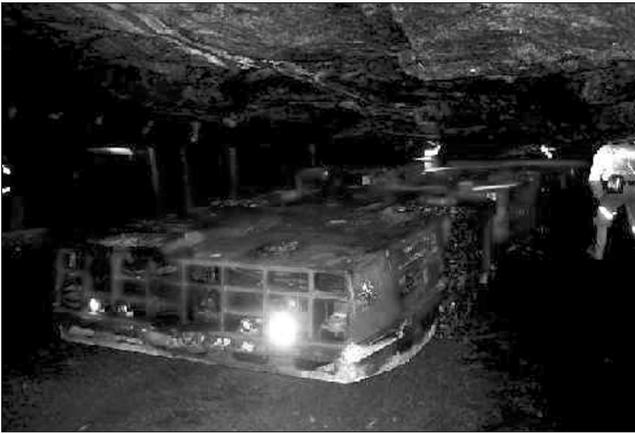
**Figure 2. Severe damage to machine extremities from undulating floors and mechanical contact with roof in an extra low profile stope (EJC 88XLP)**

To illustrate the typical extent of the damage caused to a loader frame, Figure 2 shows the damage to the frame of an extra low profile loader, the EJC 88XLP, after only a short time in service. Extensive damage can be seen on the top rear of the frame as well as on the sides from collisions with the walls in the stopes.

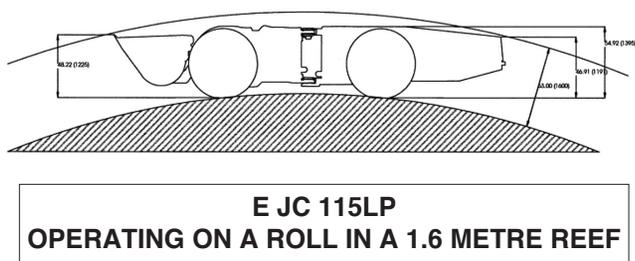
**Figure 3. CAD-simulated ideal machine profile in side view (longitudinal dimensions)**

On further examining Figure 3, the smallest radius of the convex floor that the machine will cope with is one where the centre of the dome just touches the belly of the machine with all wheels still in contact with the ground. The ground clearance here is therefore critical, as the machine will become beached on its belly with the wheels off the ground and unable to tram if there is insufficient clearance.

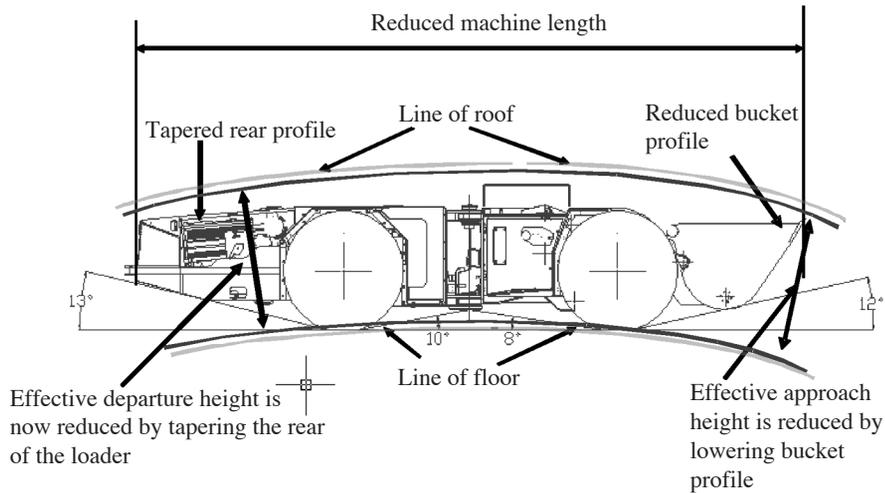
**Fig. 4. Modified EJC 115LP loader profile to accommodate design constraints. Note the tapered rear frame and the lowered bucket profile**

Conversely, if the floor is concave and the roof convex, the approach and departure angles and the ground clearance of the machine will determine the minimum radius of the floor depression. Refer to Figure 4, which shows the final design of the tapered profile of the loader with approach and departure angles on both the top and bottom of the frames.

- A short wheelbase, and track width of approximately the same dimension.
- A rounded transverse profile as well as a rounded longitudinal profile that looks like a 'used soap bar'.
- Approach, departure and hump angles all need to be approximately equal and the ideal profile is actually 'used soap bar' in shape (Figure 4).

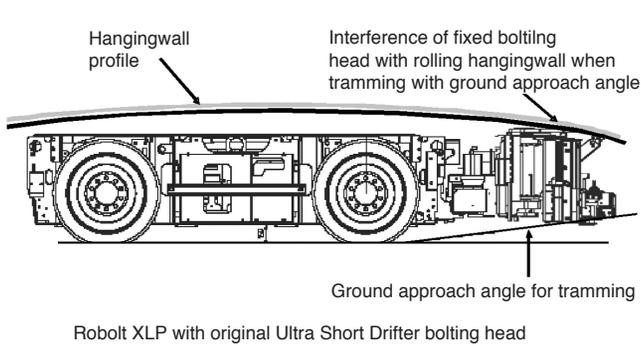
**Figure 5. Initial roof bolter profile. Bolting head is too high for effective tramming**

Figures 5 and 6 show the modifications done to a roof bolter to follow the 'used soap bar' shaped profile.

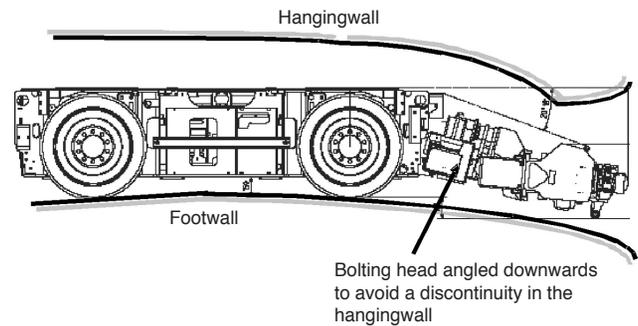
**Figure 7b. Modified bolter profile showing boom manipulation to accommodate a downwards rolling stope**

Figures 7a and b show how the machine profile can be altered dynamically using the boom hydraulics to suit the undulations in the stope.

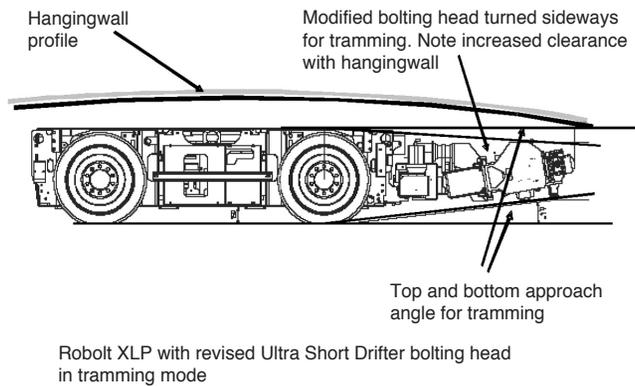
**Figure 6. Reduced profile bolter with bolting head in tramming mode shown with top and bottom approach angles to facilitate tramming**

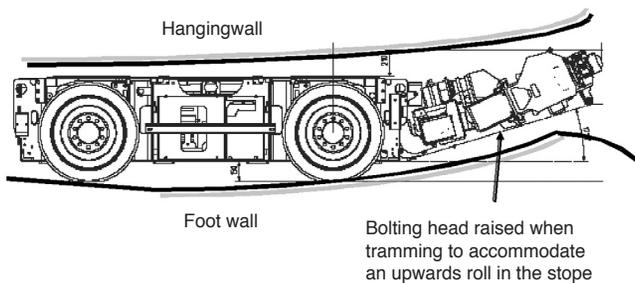
**Figure 7a. Modified bolter profile showing boom manipulation to accommodate an upwards rolling stope**

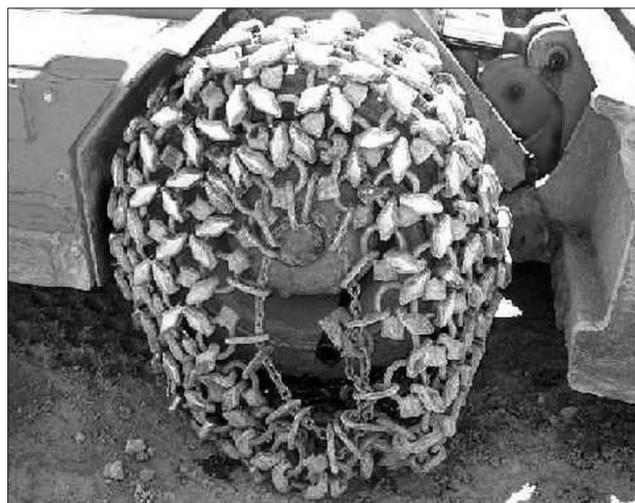
**Figure 8. Typical chain failure. The chain has slipped off the tyre**

The solid tyre and chain combination gave better tyre life than the duals and acceptable tractive effort but it was nearly impossible to keep the chain on the tyre in service, leading to frequent breakdowns and loss of loader availability. The lack of compliance of the solid tyre meant that the chains did not maintain their correct tension and needed frequent retightening or repair to damaged links from the excessive chain tensions being used to overcome the slippage. This down time from chain failures alone was

estimated to be 15% or more of shift time, reducing the machine availability from an acceptable 85% to an unacceptable 70% or less. Additionally, when the chain slipped off the tyre, it often wrapped itself around the casing of the wheel hub reduction gearbox, causing catastrophic damage to the gearbox casing on several occasions, with further down time. Different tyre side profiles were tried to cure this problem but to no avail (Figure 8).
