Introduction of 3 m cable anchors as face support in 'timber-less stopes' at Dishaba Mine

L. VAN ASWEGEN, R. JOHNSON, and G.L. SMITH
Anglo American Platinum Division

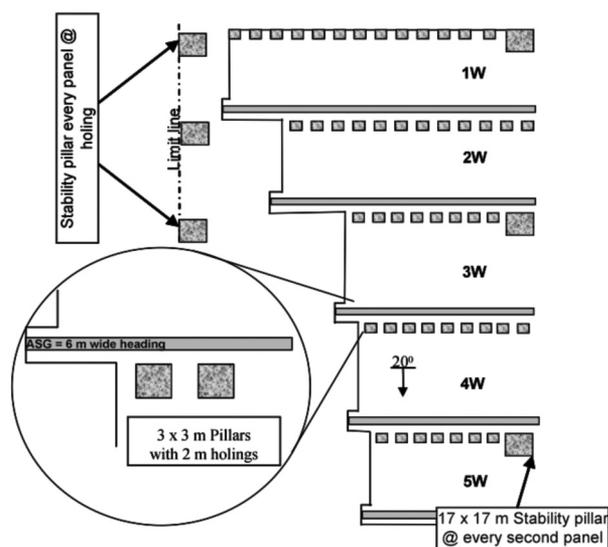
Figure 3. Typical Merensky breast mining layout at Dishaba

Mining of the Merensky Reef makes use of an underhand conventional scattered breast mining layout (see Figure 3). Regular stability pillars left at intervals complement

geological losses to ensure stability on a regional scale. Mining production panels are around 30 m long on dip. Local stability is achieved using strike crush pillars with dimensions of 3 m by 3 m that are cut at the top of each panel. Regular pillar-holings with dimensions of 3 m are cut between the pillars to allow for ventilation through the panels. These pillars were originally designed as intact pillars but at approximately 200 m depth they start yielding. Yielding and eventually crushing takes place closer to the face as the depth of the workings increases. This is desirable as the residual strength of the crush pillars is what is required to stabilize the panels.

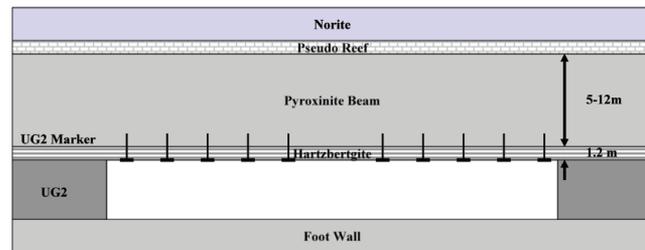
Figure 4. UG2 timber-less concept

In this support concept, the competent beam above is used to support the weak (hartzbertgite) layers below them, as shown in section in Figure 4. The 30 m beam, due to its width (thickness), is self-supporting between pillars. The previously used support design had a capacity to support only 1.5 m of hangingwall and would fail if the demand exceeded it. The timber-less project proved successful in the panels where it was applied, but was limited to a small number of Tumela UG2 panels (trial panels). Such a panel is shown in Figure 5. This support system was not readily accepted by production crews, most probably due the psychological effect of no visible support over a considerable area.

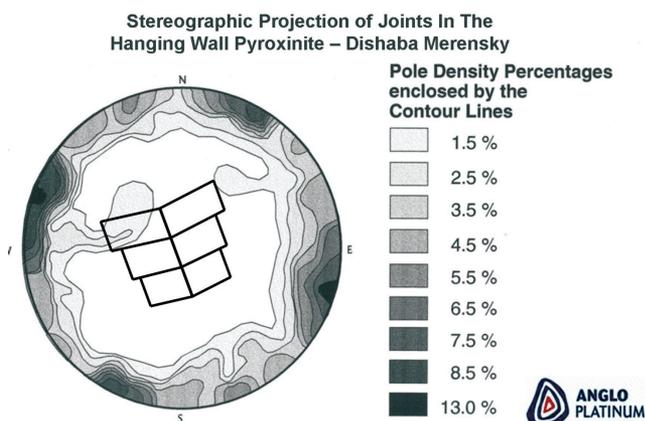
Figure 6. ‘Normal’ joint sets at Dishaba No. 2 shaft

The orientation of ‘normal’ joint sets in the Merensky reef areas of Dishaba 2 Shaft are shown in Figure 6. The principle joint set, ‘J1’, strikes sub-parallel to the north-south direction with the secondary set close to perpendicular to the first set. Both joint sets are steep, typically $90^\circ \pm 10^\circ$.

The joint sets, shown in Figure 6, are not the cause of falls of ground per se, but normally form one of the boundaries of such falls. However, alterations of both joint sets, such as a lower dip angle, opposite dip angles and infilling and water, often cause falls of ground as shown in Figure 7. The shown fall of ground originated from J1 combined with a low angled joint parallel to J1. The length of the fall is orientated parallel to the face and fell out after the last blast. The height of the fall of ground is approximately 2 m at its apex. Randomly orientated joints and domes are often intersected and also contribute to large falls of ground taking place.

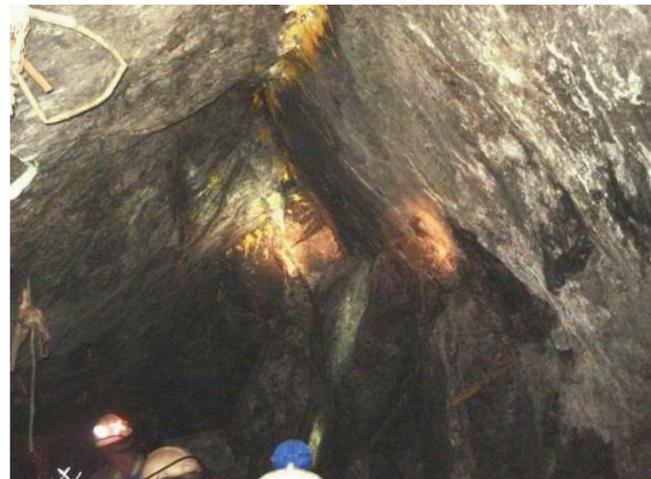
Figure 7. View down-dip of a fall of ground from an altered J1

In addition to the above, a combination of domed or flat dipping structures with J1 or J2 is often intersected resulting in further falls of ground. (Figure 7.)

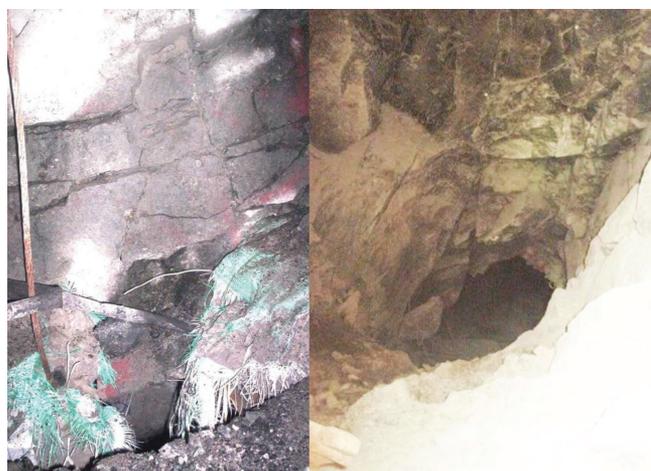
Figure 9. Sections into the hangingwall of the Merensky Reef

Figure 9 is a combination of two slides that were taken in off-reef gullies, facing the down-dip direction. The slide on the left hand side represents a section through a stope hangingwall and the one on the right shows the hangingwall above a re-raise to a depth of more than 3 m. It is obvious from both these slides that a combination of flat dipping

and steep dipping joints are present in the Merensky Reef hangingwall, that, in many areas, could be described as a broken-up mass of rock.

What was also apparent in the left-hand picture of Figure 9 was the amount of dilation (opening of joints) that took place inside the hangingwall of the reef and the thick serpentinized infill that is present in some joints.

Logging of geotechnical hangingwall bore holes of Merensky stopes (Figure 8) and exposed sections of the hangingwall of the Merensky Reef (Figure 9) indicated that the rock mass rating (Bieniawski¹ RMR) of the stope hangingwall varied between a lower Class IV to Class V conditions.

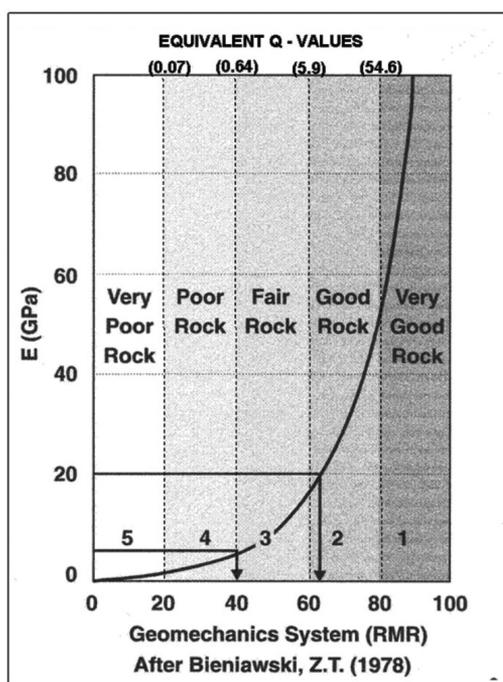
Figure 10. Estimation of the RMM using RMR values

To use the Beer and Meek² Voussoir arch graphs to estimate the support demand, the 'rock mass modulus' (RMM) had to be estimated. The Bieniawski¹ relationship, as shown in Figure 10, was used for this purpose. Rock with an RMR between 10 and 30 will have an RMM between 2 and 5 GPa. These values were used to estimate the support demand using a similar relationship with the NT Beam program as the relationship established by Beer and Meek² as shown in Figure 11. This figure indicates that the hangingwall beam thickness that had to be supported was approximately 3 m, i.e. 90 kN/m². This figure correlated well with the demand established with the cumulative fall of ground frequency graph shown in Figure 12.

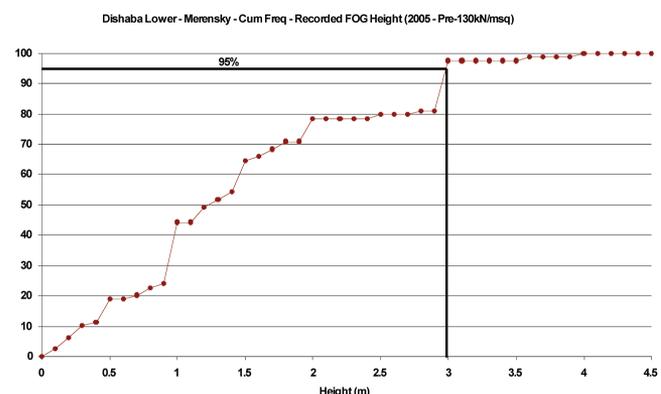
Figure 12. Cumulative frequency graph of 2005 fall of ground database

The FOG database that was compiled during 2005, shown in Figure 12, was used for this exercise. This database was accumulated before adjustments to the support standard were made and is therefore a good indication of the problem that had to be solved. This database also confirmed

that a hangingwall height of approximately 3 m had to be supported.

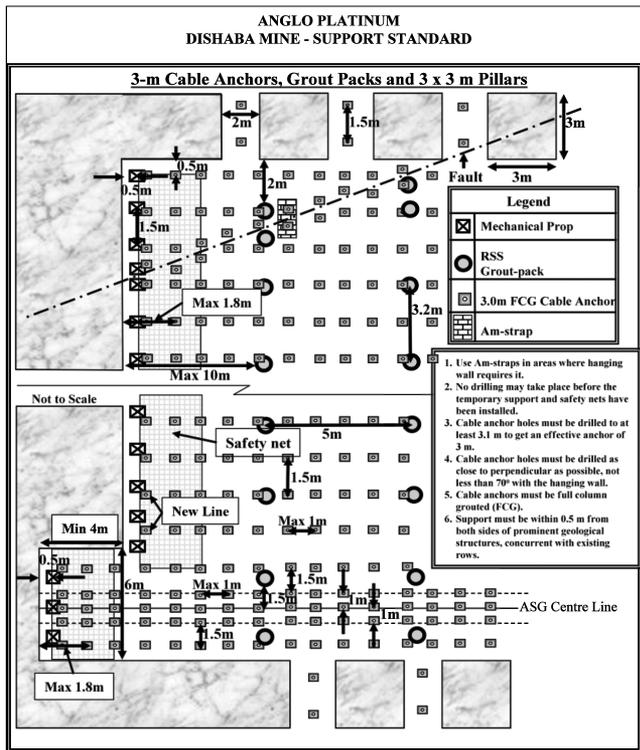
Figure 13. 3 m Cable anchor support layout

The average advance for Merensky panels at Dishaba Mine was 0.9 m. The dip spacing of the support was kept at 1.5 m, the same as for all other previously used tendons due to this being an adequate frequency for the prevailing joint spacing. It also ensures an adequate overlap of the zone of influence as shown in Figure 28. The factor of safety for this support is 2 for a strike spacing of 0.9 m. The stipulated maximum strike spacing is 1 m, which would still give a FOS of 1.9. This value drops to 1.5, if the support capacity is downrated by 20% to 200 kN for possible poor installations, which is quite acceptable for any type of support. The support layout is schematically shown in Figure 13.

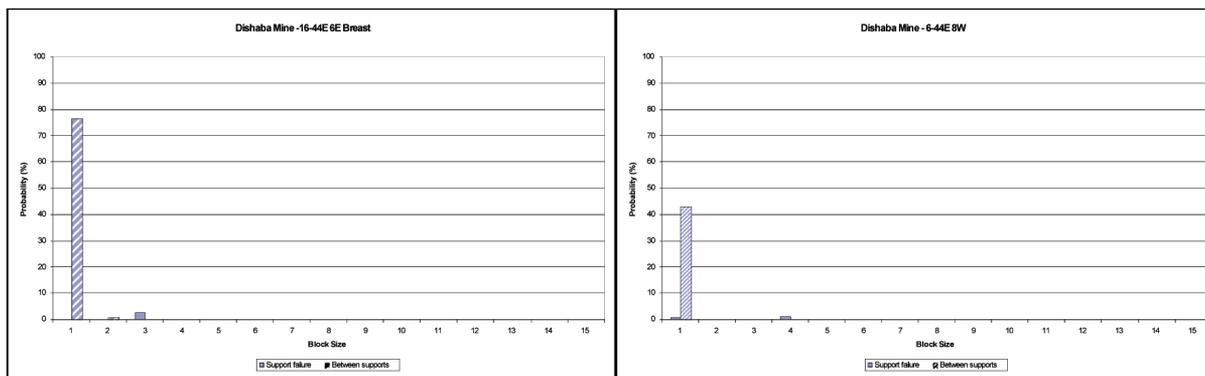
Figure 14. Probability of failure for 3 m anchors in 16-44E 6E and 8W

that uses joint information to generate possible wedges and evaluate the probability that these wedges will either fail the installed support or fall out between support units. Results from runs, as shown for a specific area in Figure 14, indicated a very low probability of failure.

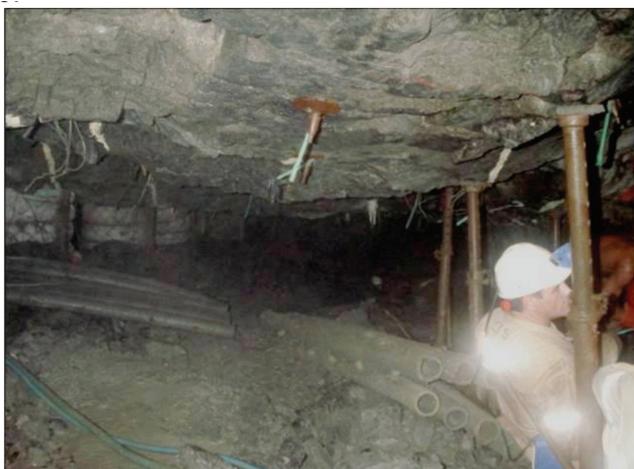
Figure 15. Panel supported with 3 m cable anchors and grout packs

A panel that has been supported with 3 m cable anchors and grout packs is shown in Figure 15.

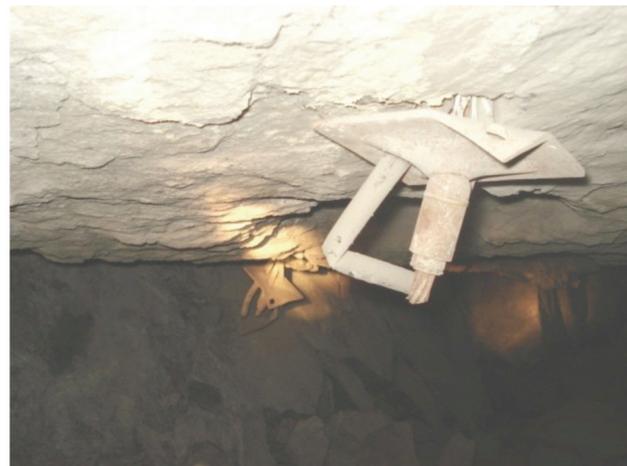
Figure 16. Case 1 FOG showing untensioned anchors

Case 1: This panel was part of one of the first stopes that was converted to 3 m cable anchor support. In this instance it was noted that the cable anchors were not properly tensioned over a large distance. This caused the wedges that are supposed to resist 'slip' over the tendon to slip as they have not been 'seated'. Closure in this stope was approximately 100 mm at the time of the investigation. It was obvious that the area was mostly being supported by the back area packs that were installed. A large fall of ground subsequently took in the face area of the panel. It is evident in Figure 16 that the load indicator did not extrude

and that the anchor was not tensioned upon installation as shown in Figure 16.

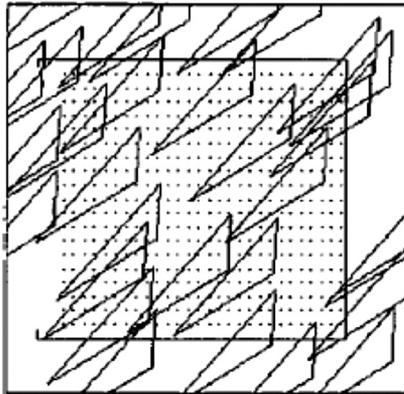
Figure 17. J-Block results for Case 1

The dimensions and orientation of this block was subsequently modeled with J-Block single block analyses. This analyses indicated that the block would not have fallen if the support were correctly installed and to standard as shown in Figure 17.

Block probability of failure
 Area modelled :140540.02
 Probability of block failing the support : 0.00%
 Probability of block dropping out between support : 0.00%
 Probability of block over abutment : 79.54%
 Percent tendons too short = 0.42%

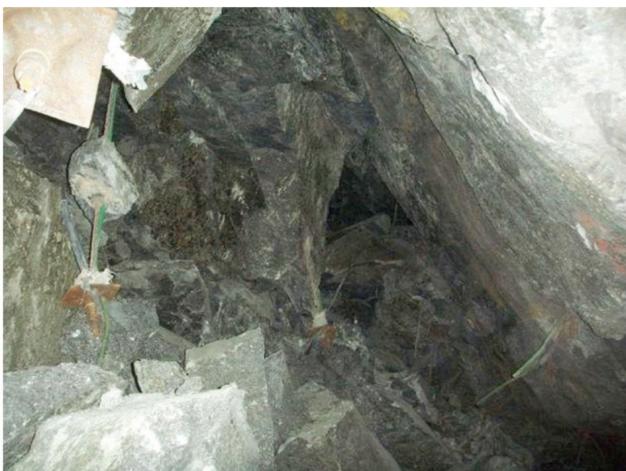
Figure 18. Case 3 FOG from UG2 hanging wall

Case 3: A large fall of ground occurred from the hanging wall of a UG2 stope as shown in Figure 18.

The fall of ground took place from the hangingwall of a UG2 stope. The UG2 Reef was not intended for this report but this fall of ground was included for completeness. In this case one of the boundaries was formed by a fault. The hangingwall adjacent to the fault was very serpentinized and blocky.

Evidence from the underground investigation showed that the support was installed to a good quality in the area surrounding the fall. One can therefore assume that the support within the area of the fall was also installed to a good standard. The fall of ground therefore took place as a result of the extremely broken and serpentinized nature of the hangingwall. In this case the area adjacent to the fault (on its weak side) should have been identified and left as pillar.

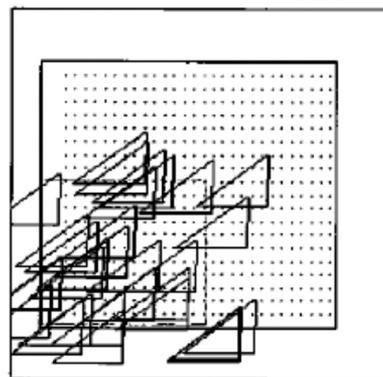
Figure 19. J-Block results for Case 3

The J-Block single block analyses (Figure 19) again showed that if the support were installed correctly, the block would not have fallen.

Block probability of failure
 Area modelled :108154.46
 Probability of block failing the support : 0.00%
 Probability of block dropping out between support : 0.00%
 Probability of block over abutment : 47.44%
 Percent tendons too short = 8.88%

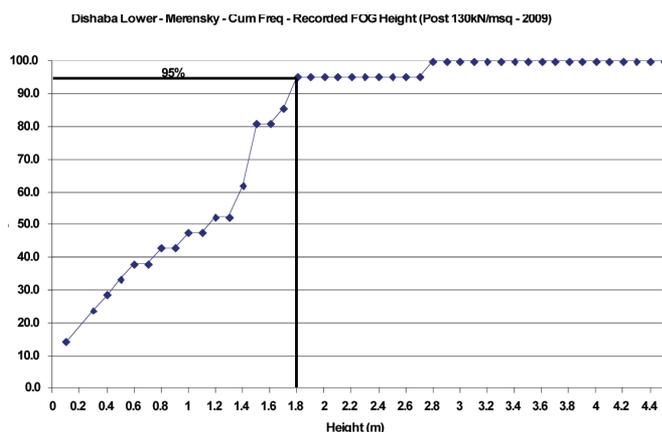
Figure 20. Cumulative frequency graph after increasing the support resistance to 130 kN/m² and introduction of 3 m cable anchors

It is obvious from Figure 20 that the sizes of falls of grounds have been greatly reduced after upgrading the support resistance to more than 130 kN/m² and the subsequent introduction of 3 m cable anchors.

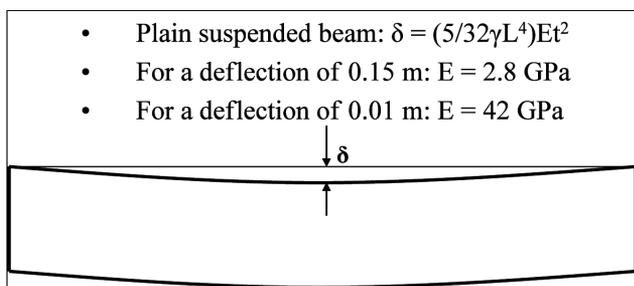
Figure 21. Equations for a plain suspended beam

The large reduction in stope closure after the introduction of 3 m cable anchor support was not expected. This can only be explained with 'beam equations', i.e. deflection of a plain suspended beam as shown in Figure 21. If one considers a 3 m beam with a length of 30 m with a total deflection of 0.15 m (as was observed underground with pencil sticks that also had the capacity to support 3 m of hangingwall) then the modulus of the beam is back calculated as 2.8 GPa, which correlates well with the Bieniawski¹ and Beer and Meek² graphs discussed earlier. Similarly, a beam deflecting only 0.01 m has a modulus of 42 GPa. One can therefore conclude that the cable anchor support reinforces the beam to such an extent that the modulus is theoretically increased to 42 GPa. A competent beam is thus created that is stable at the spans between face, pack support, and pillar abutments underground.

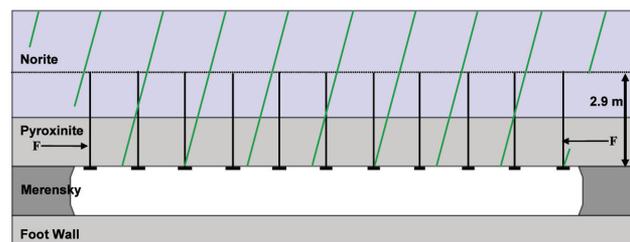
Figure 22. 3 m cable anchors with 750 joints in a 20 m panel

Every third joint is missed in the case of 750 joints as shown in Figure 22. These joints are therefore reliant on their cohesions and the horizontal stress in the hangingwall to keep them stable. To investigate this, one needs to consider the stress components on a joint as shown in Figure 23.

To further understand the 'mode of support' of 3 m cable anchors, a series of sketches depicting a section through a stope panel with various joint angles was created and is shown in Figures 22 to 27.

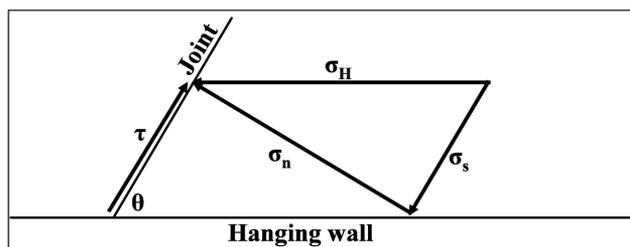
Figure 23. Vector components of horizontal stress influence on joint

From Figure 23 consider the following: $\tau = \sigma_n \tan \phi + c$. For stability $\tau = \sigma_s$. If the influence of cohesion and gravity is excluded then $\tan \phi = 1/\tan \theta$. For various values of the friction angle the stable joint angle is shown in Table III.

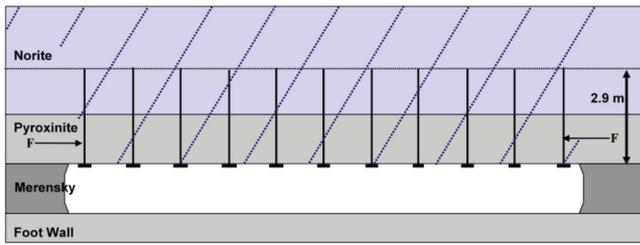
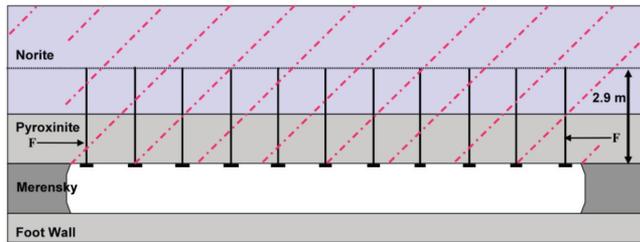
From Figures 24 and 25 it is apparent that lower angled joints will be more readily penetrated by cable anchors.

Figure 24. 3 m cable anchors with 60° joints in a 20 m panel

Figure 25. 3 m cable anchors with 45° joints in a 20 m panel

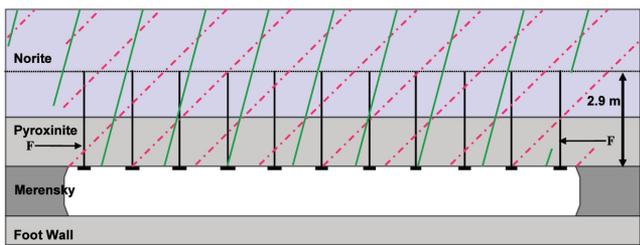
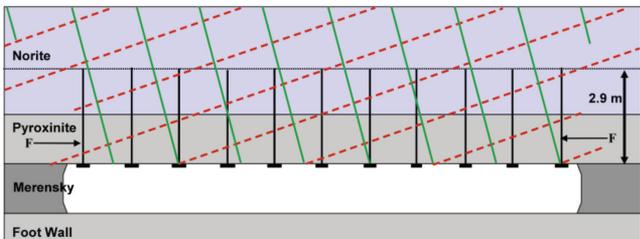
The support effect of cable anchors on joints dipping in opposite directions is the same as previously discussed as shown in Figures 26 and 27.

Figure 26. 3 m cable anchors with 45° and 75° joints in a 20 m panel

Figure 27. 3 m cable anchors with 45° and 75° joints in a 20 m panel dipping in opposite directions

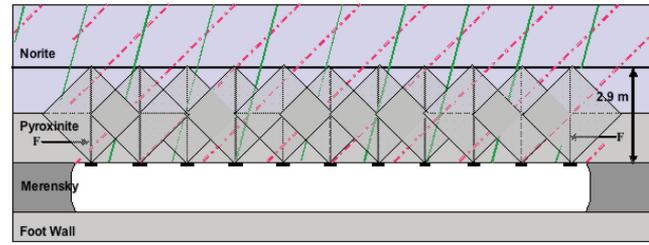
Figure 28. The zone of influence of 3 m cable anchors installed at 1.5 m spacings in a rock mass with an internal angle of friction of 45°

The zone of influence of 3 m cable anchors installed at 1.5 m spacings is quite considerable, as shown in Figure 28. This is a simplified model as the zone will reduce slightly
